SADLIERS RIVER BRIDGE – QUEENSLAND ROAD – AUSTRALIA

In July to October 2009, **ZINGA Australia** offered **Queensland Road** the solution for refurbishment by applying a **ZINGA** unique system for sustainable long-time protection of this **Heritage** structure.

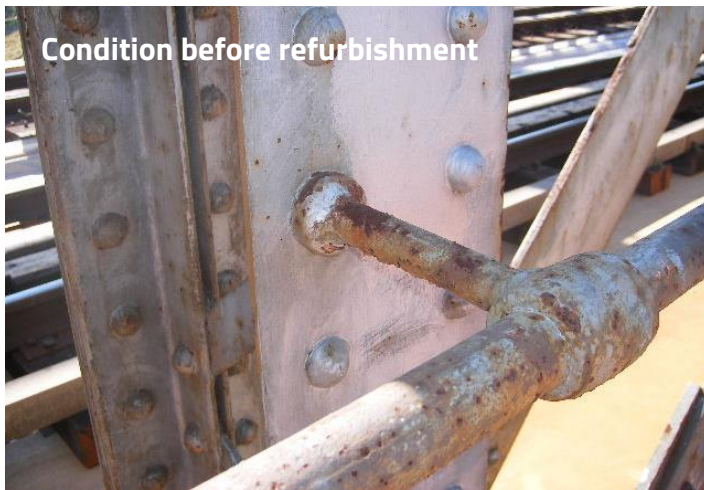
Condition before refurbishment

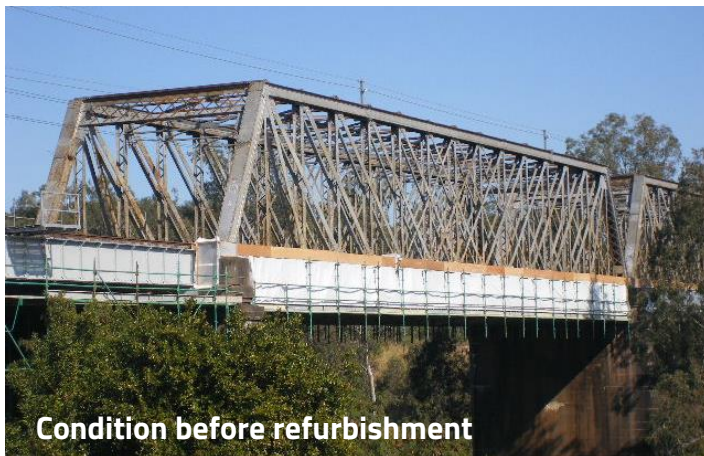
Condition before refurbishment

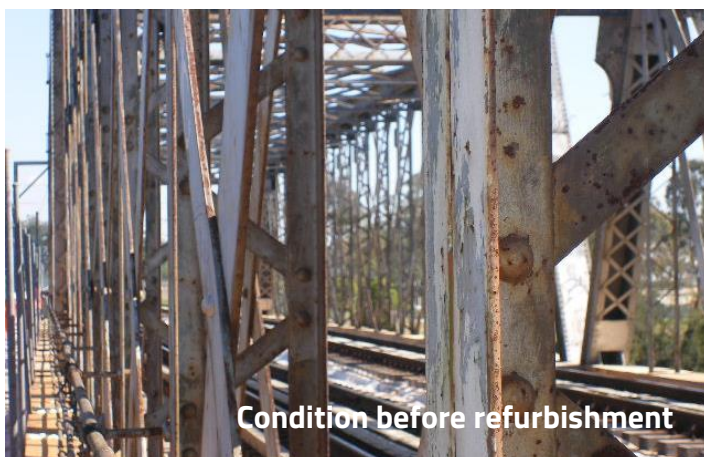
Condition before refurbishment

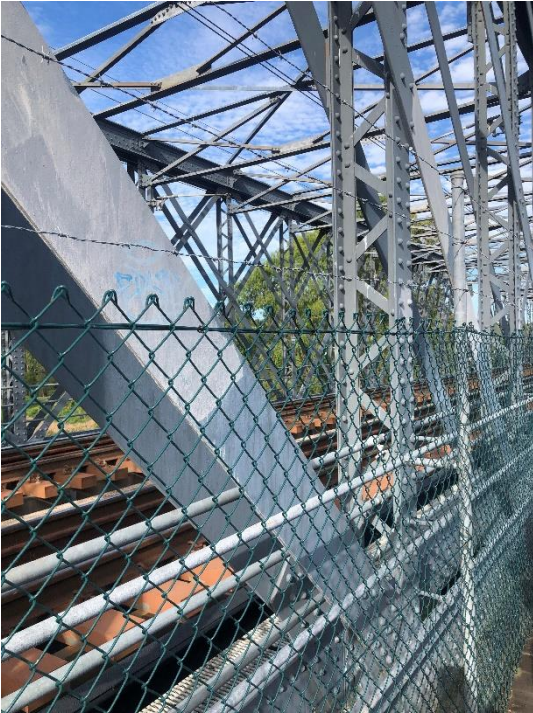
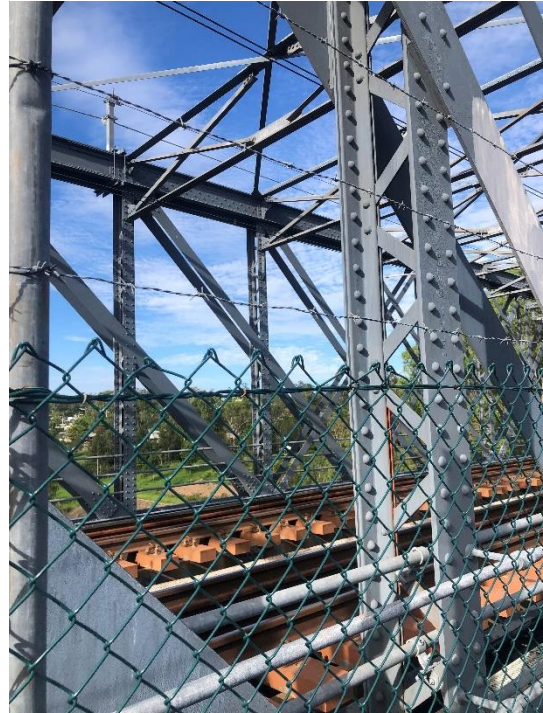
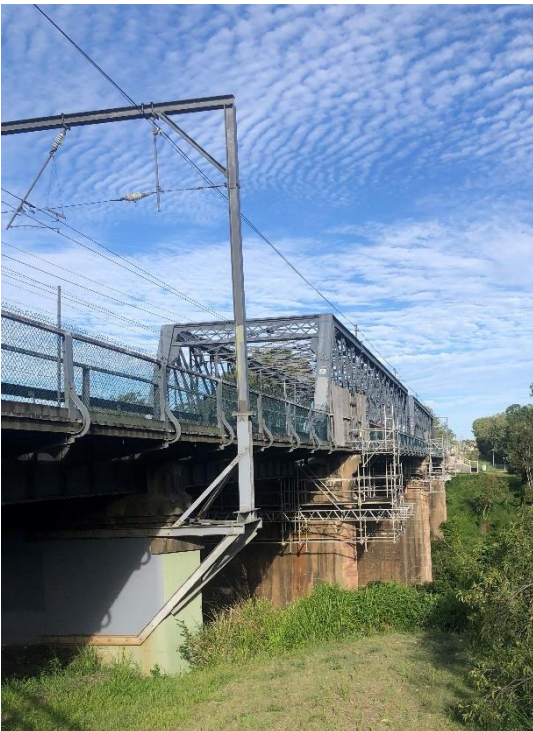
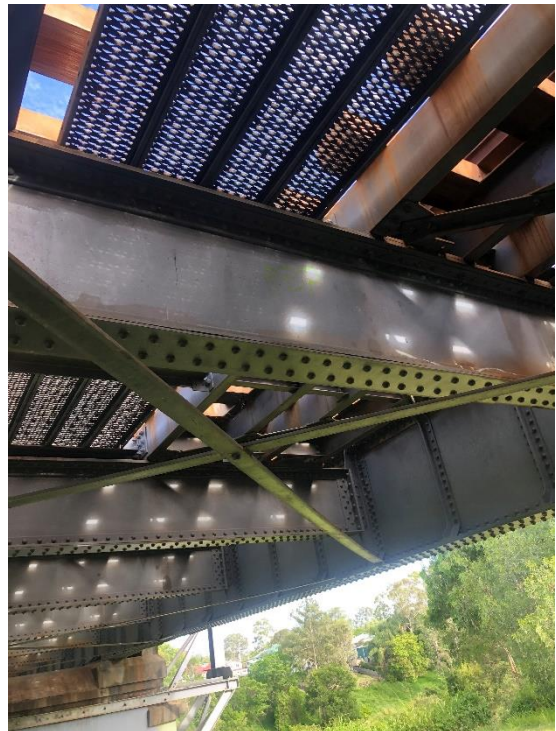
In December 2023, 14 years after the original application, a representative of ZINGA Australia and of ZINGAMETALL Belgium went on site for making a condition survey. You can find their photos below.

The brown spots you see in the photo on the right come from tannin drippings from the wooden sleepers. After a light wash with water these surfaces showed a perfect ZINGANIZED finish.
