## BJØRNETANGEN BRIDGE – Viken Fylkes, NORWAY

The **BJØRNETANGEN bridge** is located in the Viken Fylkes Kommune in Norway. This bridge goes over the Snarumselva river and is 79 meters long. The previous coating system (zinc rich primer + topcoat) was failing in a quite early stage (pictures below).

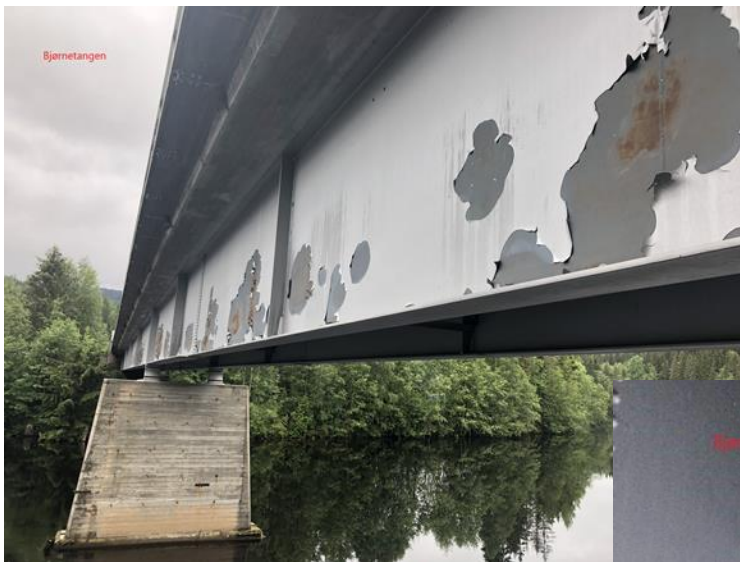
The previous coating system failed !

During the summer of 2021 the **VIKEN FYLKESKOMMUNE Authorities** decided to repair it with a **ZINGA** stand-alone system of 2 x 60 µm DFT, which they ordered to **ZINGA AS**, the Norwegian **ZINGA** Distributor.

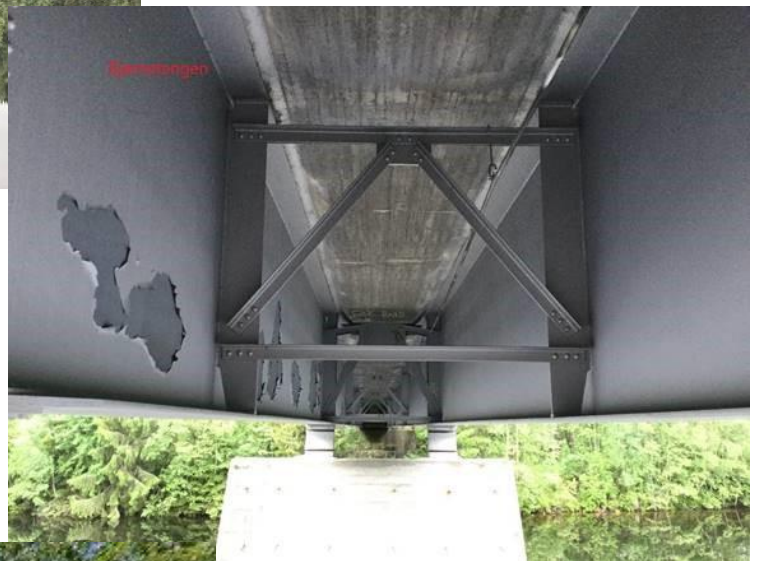
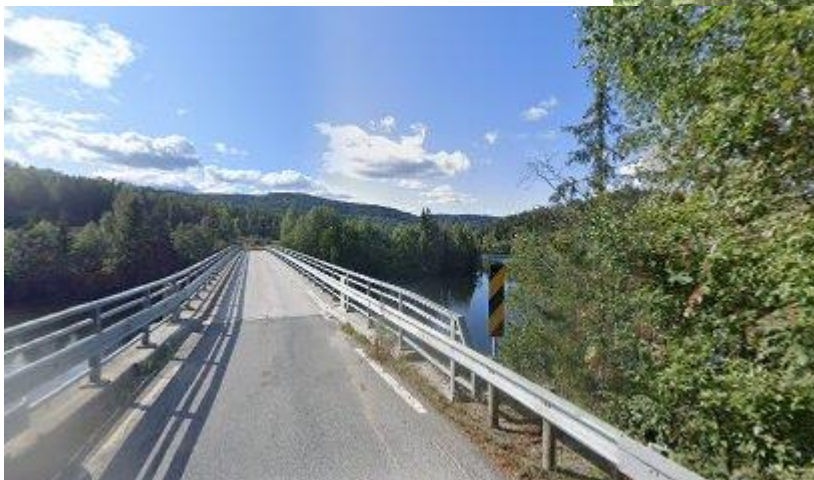
System:  
Blasting to SA 2.5  
ZINGA 120 µm DFT

The repair works with the **ZINGA** film galvanizing system were executed by **CONSOLVO AS**, a paint contractor that has long and very good experiences with the application of **ZINGA**. This **BJØRNETANGEN** bridge refurbishment is the first of a series of 7 bridges to be repaired for the **VIKEN FYLKESKOMMUNE Authorities**.

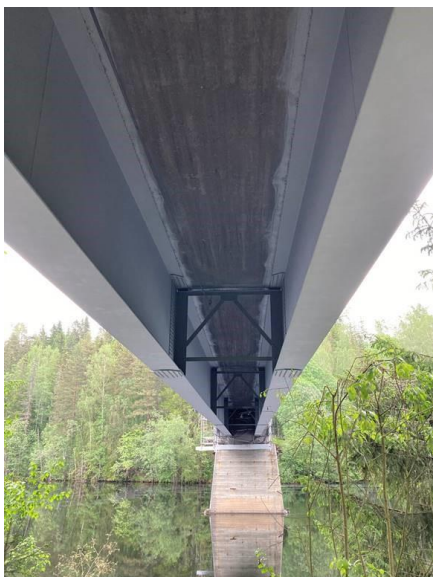
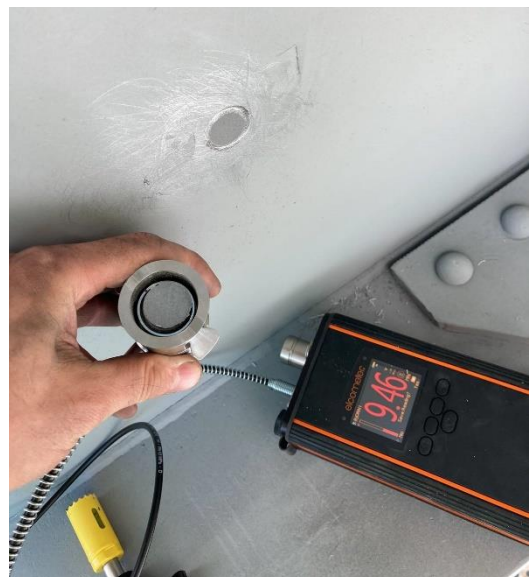
A pull-off test was performed 7 days after application of the **ZINGA** system: 9.46 MPa !
