# Test Report

## ZINGA on laser cleaned panels

Laser cleaning is getting more attention as a clean alternative for blast cleaning as it practically eliminates (toxic) dust production and is much safer to work with.

This test is to see how ZINGA would be suitable for steel surfaces which are cleaned and given a desired surface profile by the method of laser cleaning. Two steel panels were cleaned using this method as also two panels which were previously hot dip galvanised after which ZINGA was applied to examine the compatibility.

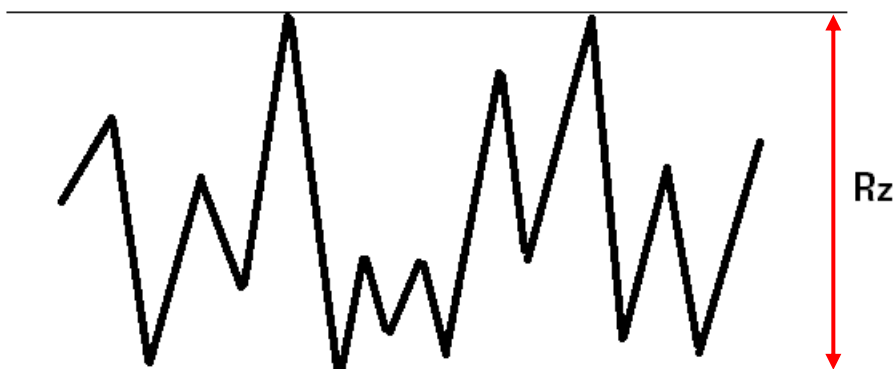
Figure 1. Simplified representation of rough surface with Rz measurement.

Panel 1 (HDG)	Panel 2 (HDG)	Panel 3	Panel 4
Surface Roughness = Rz ( $\mu\text{m}$ )	68 – 84	96 – 110	72 – 78	60 – 64

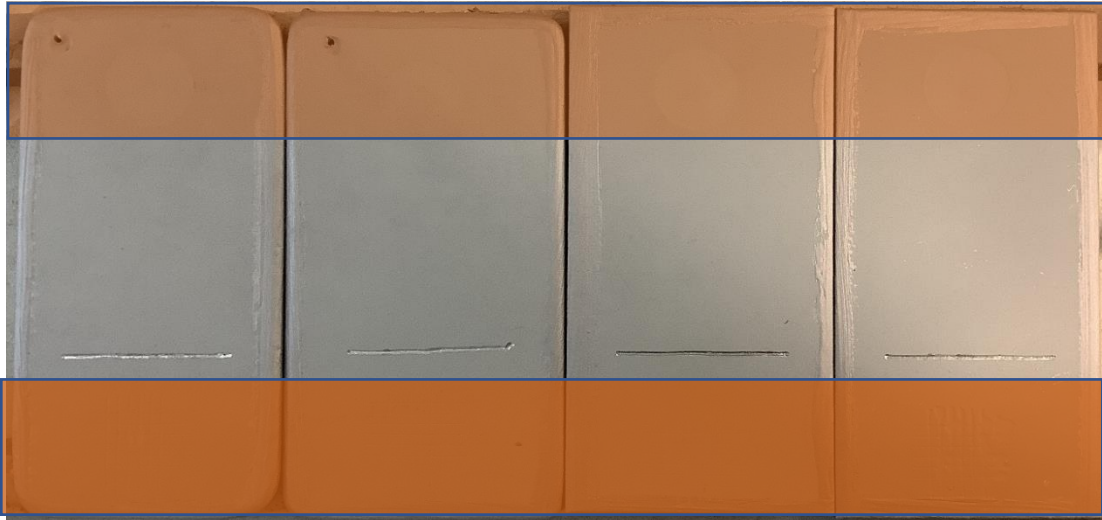
Figure 2. Panels 1 - 4 (left to right) at start of salt spray testing.

\*The areas underneath the orange blocks are not taken into account due to reduced coating thickness by previous testing (pull off).

System	DFT	Observations
Test panel 1	HDG + ZINGA	299	No observations
Test panel 2	HDG + ZINGA	267	No observations
Test panel 3	ZINGA	110	No observations
Test panel 4	ZINGA	133	No observations

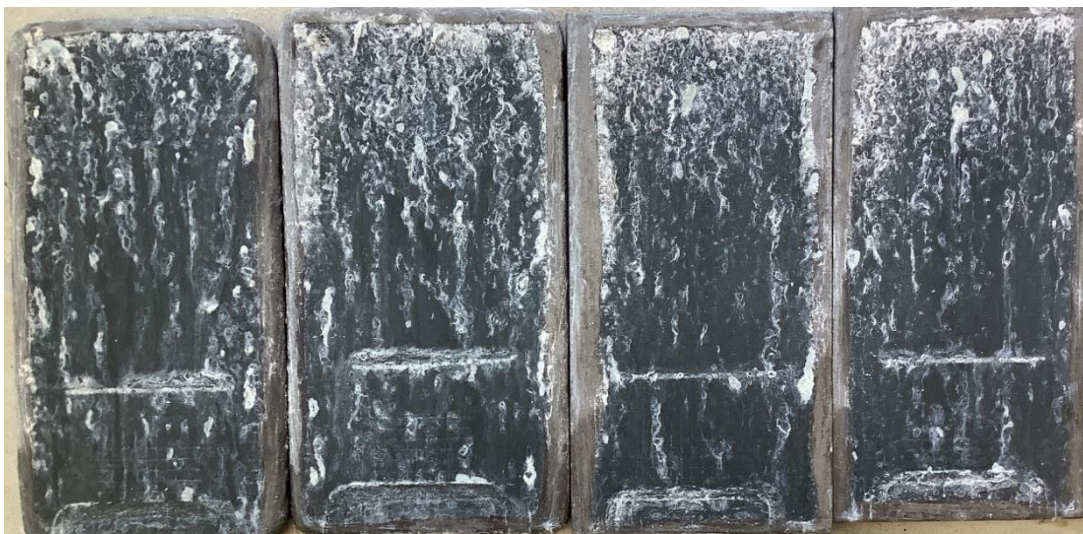
Figure 3. Panels 1 - 4 (left to right) at 645 of salt spray testing.

System	DFT	Observations
Test panel 1	HDG + ZINGA	299	No observations
Test panel 2	HDG + ZINGA	267	No observations
Test panel 3	ZINGA	110	No observations
Test panel 4	ZINGA	133	No observations

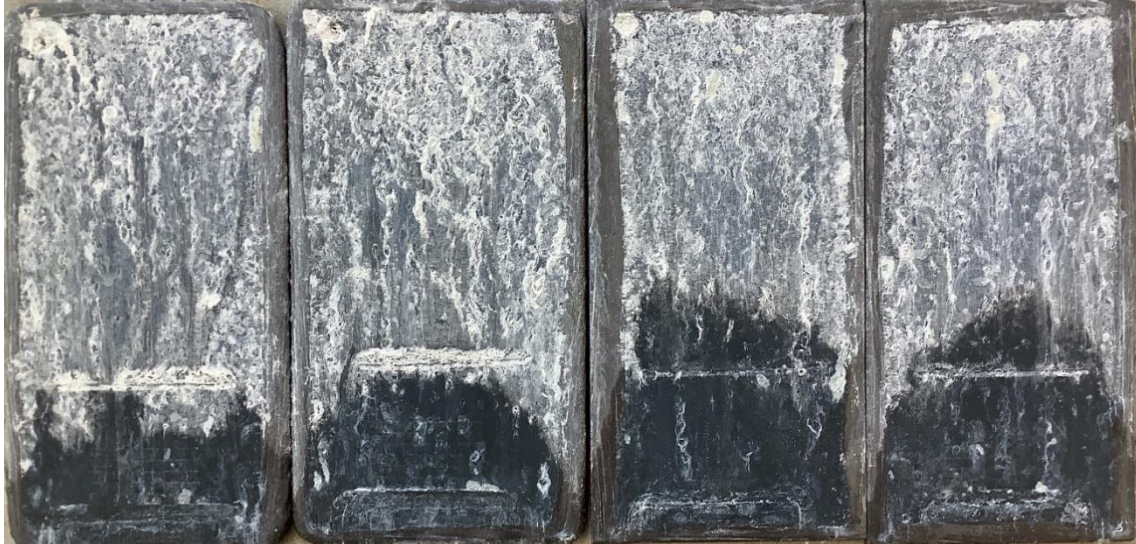
Figure 4. Panels 1 - 4 (left to right) at 1000 hour of salt spray testing.

<b>System</b>	<b>DFT</b>	<b>Observations</b>
<b>Test panel 1</b>	HDG + ZINGA	299	No observations
<b>Test panel 2</b>	HDG + ZINGA	267	No observations
<b>Test panel 3</b>	ZINGA	110	No observations
<b>Test panel 4</b>	ZINGA	133	No observations

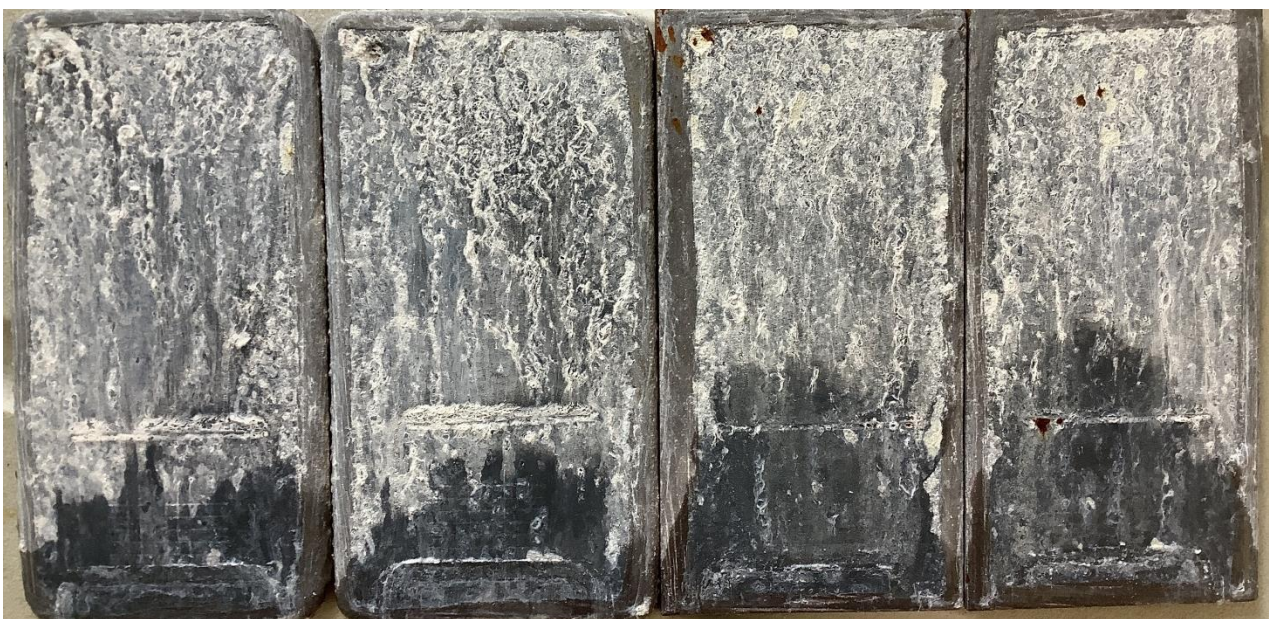
Figure 5. Panels 1 - 4 (left to right) at 1440 hour of salt spray testing.

<b>System</b>	<b>DFT</b>	<b>Observations</b>
<b>Test panel 1</b>	HDG + ZINGA	299	No observations
<b>Test panel 2</b>	HDG + ZINGA	267	No observations
<b>Test panel 3</b>	ZINGA	110	Rust in scribe
<b>Test panel 4</b>	ZINGA	133	Rust in scribe

The panels all passed the requirements of ISO12944-C5 High as no visible defects were observed after 1440 hours of salt spray testing. Adhesion values have increased after artificial ageing (salt spray chamber). The latter values would be even higher as almost all pull offs experienced glue failure due to the high salt formation on top of ZINGA.

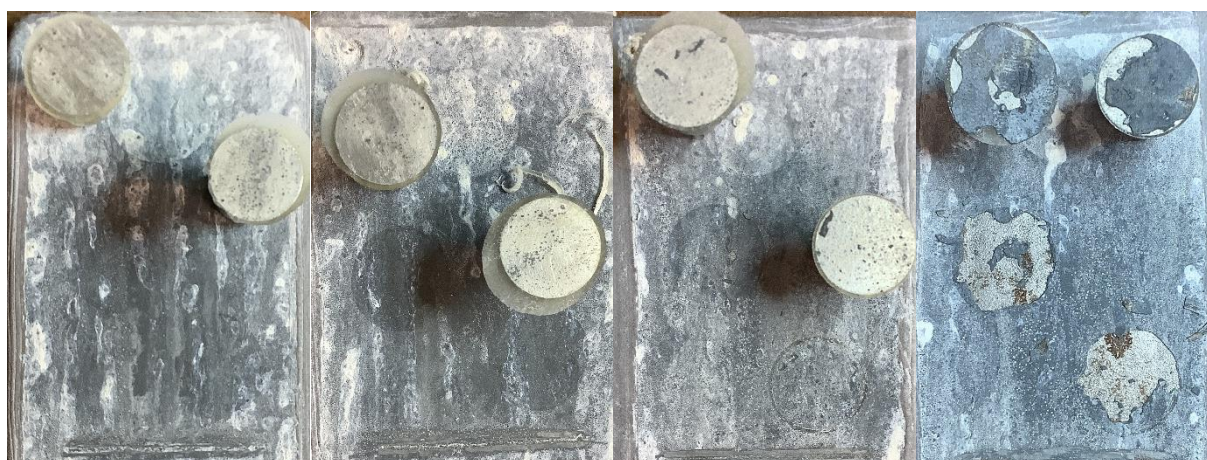
Figure 6. Pull off on panels 1 - 4 (left to right) after qualification testing.

Method		Test panel 1	Test panel 2
Rz (µm)		68 – 84	96 – 110
DFT (µm)		299	267
ISO 4628-2 Blistering		0 (S0)	0 (S0)
ISO 4628-3 Rusting		Ri 0	Ri 0
ISO 4628-4 Cracking		0 (S0)	0 (S0)
ISO 4628-5 Flaking		0 (S0)	0 (S0)
Corrosion from scribe (mm)		0,0	0,0
ISO 4624 method B Pull Off	DFT (µm)	320 / 290	260 / 290
	Value (MPa)	5,3 / 4,9	5,2 / 4,6
	Brake	100% B/Y / 100% B/Y	100% B/Y / 100% B/Y
Comments:		Pull off: glue failure	Pull off: glue failure

Method		Test panel 3	Test panel 4
Rz (µm)		72 – 78	60 – 64
DFT (µm)		110	133
ISO 4628-2 Blistering		0 (S0)	0 (S0)
ISO 4628-3 Rusting		Ri 0	Ri 0
ISO 4628-4 Cracking		0 (S0)	0 (S0)
ISO 4628-5 Flaking		0 (S0)	0 (S0)
Corrosion from scribe (mm)		0,0	0,0
ISO 4624 method B Pull Off	DFT (µm)	150 / 140	160 / 165
	Value (MPa)	4,6 / 3,4	3,4 / 3,0
	Brake	100% B/Y / 100% B/Y	90% A/B – 10% B/Y / 80% A/B – 20% B/Y
Comments:		Pull off: glue failure	Rust underneath ZINGA layer
