## REYNELLA BRIDGE – ADELAIDE – AUSTRALIA

Refurbishment of the Reynella Bridge in South Australia (South of Adelaide) by means of a **ZINGA** duplex system in June 2008.

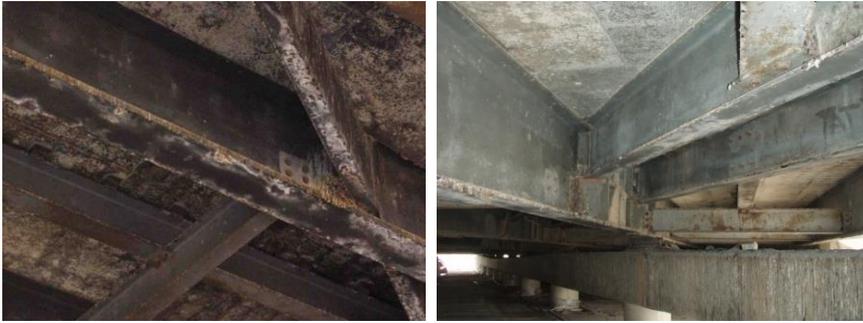
These pictures clearly indicate the high degree of corrosion before refurbishment with the **ZINGA** system.
