## WILCO TRUCK & TRAILER FRAMES – HØNEFOSS – NORWAY

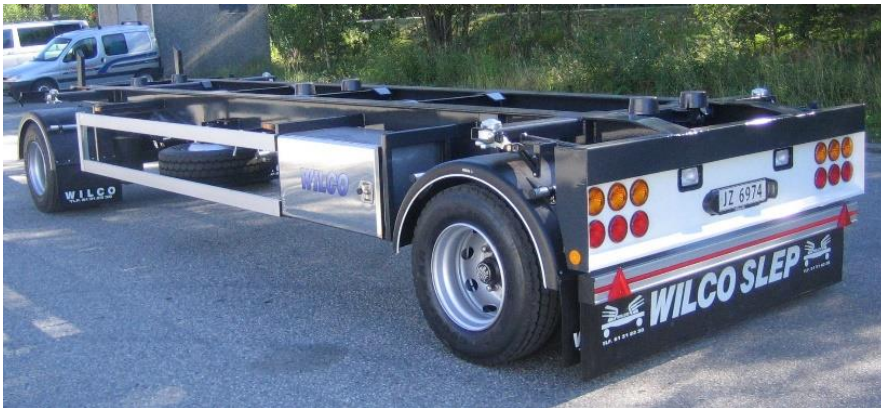
**ZINGA** was used in 2007 for this frame. These pictures were taken in 2018.

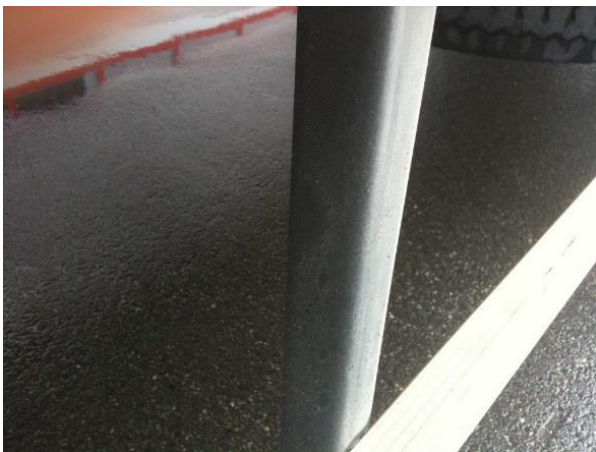
The rusted brackets were Not protected with **ZINGA**

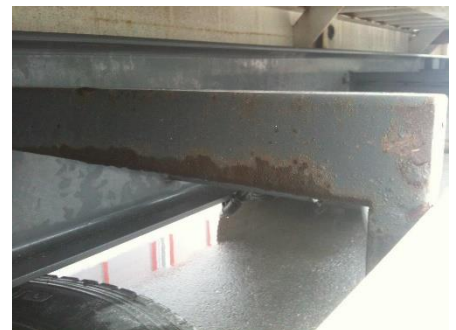
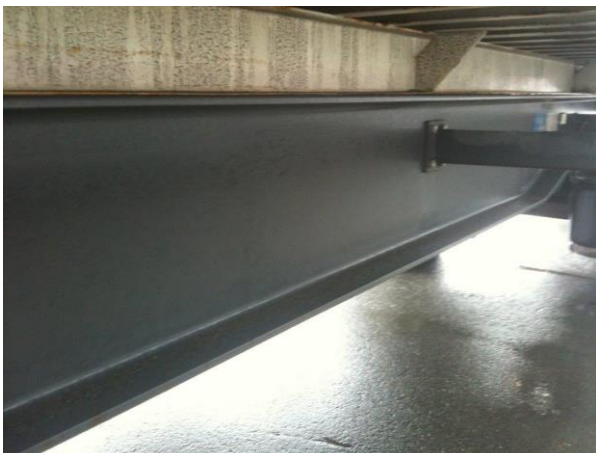
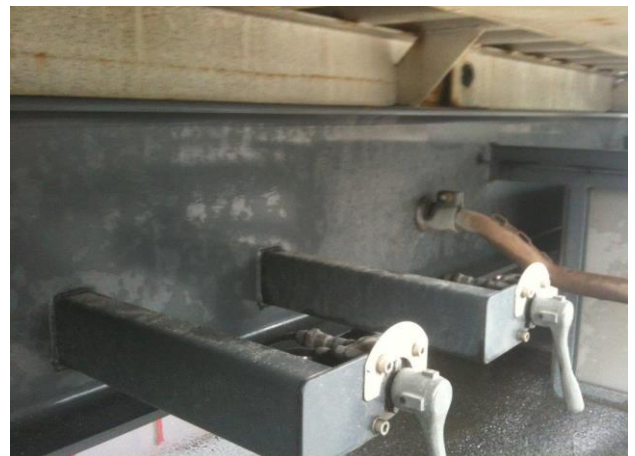
System:  
 Surface preparation: Blasting to SA 2,5  
**ZINGA** 1 x 60 µm DFT  
 Topcoat (different brands) 2 x 100 µm DFT

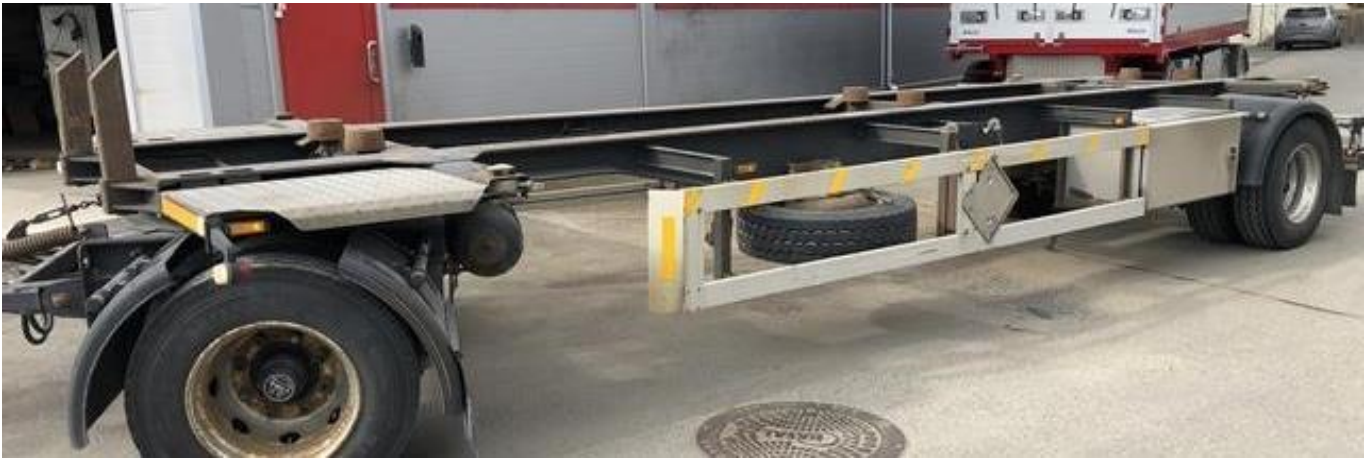
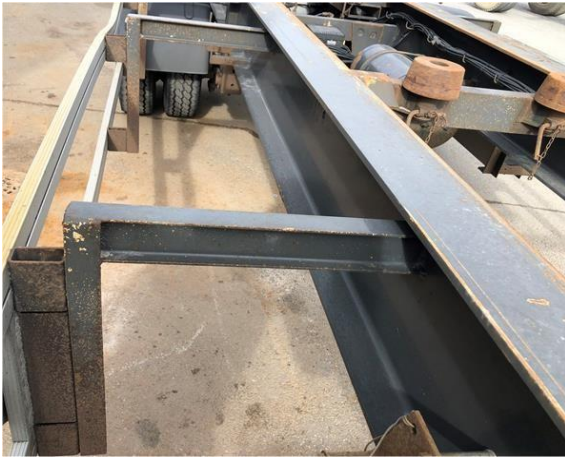
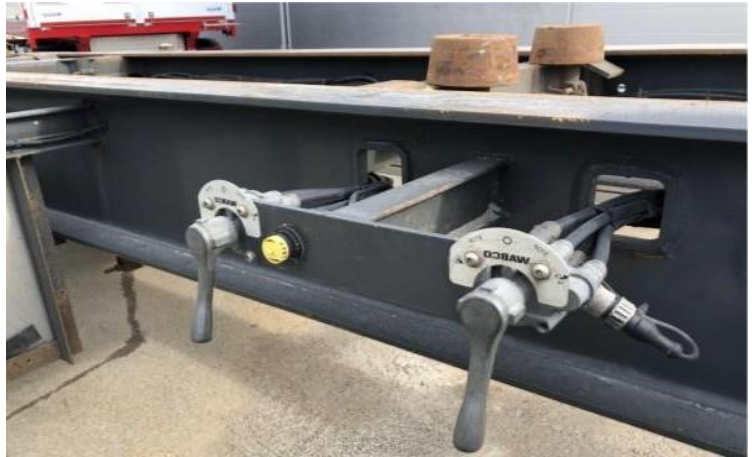
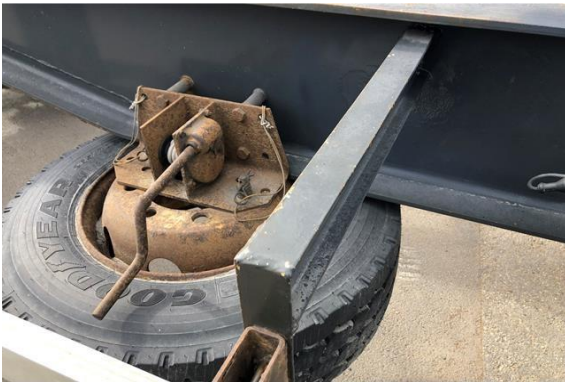
This frame was built in December 2010. These pictures were taken **10 years after**, in October 2020, after having traveled 1,000,000 km ! (the visible heavy rusted parts were protected with a traditional paint system and DINITROL.)
